Title: Mechanical Properties of an Irradiated Inconel 718 Beam Window

Mechanical Properties of an Irradiated Inconel 718 Beam Window

Isotope Production Facility - LANSCE

Irradiation Damage and Replacement

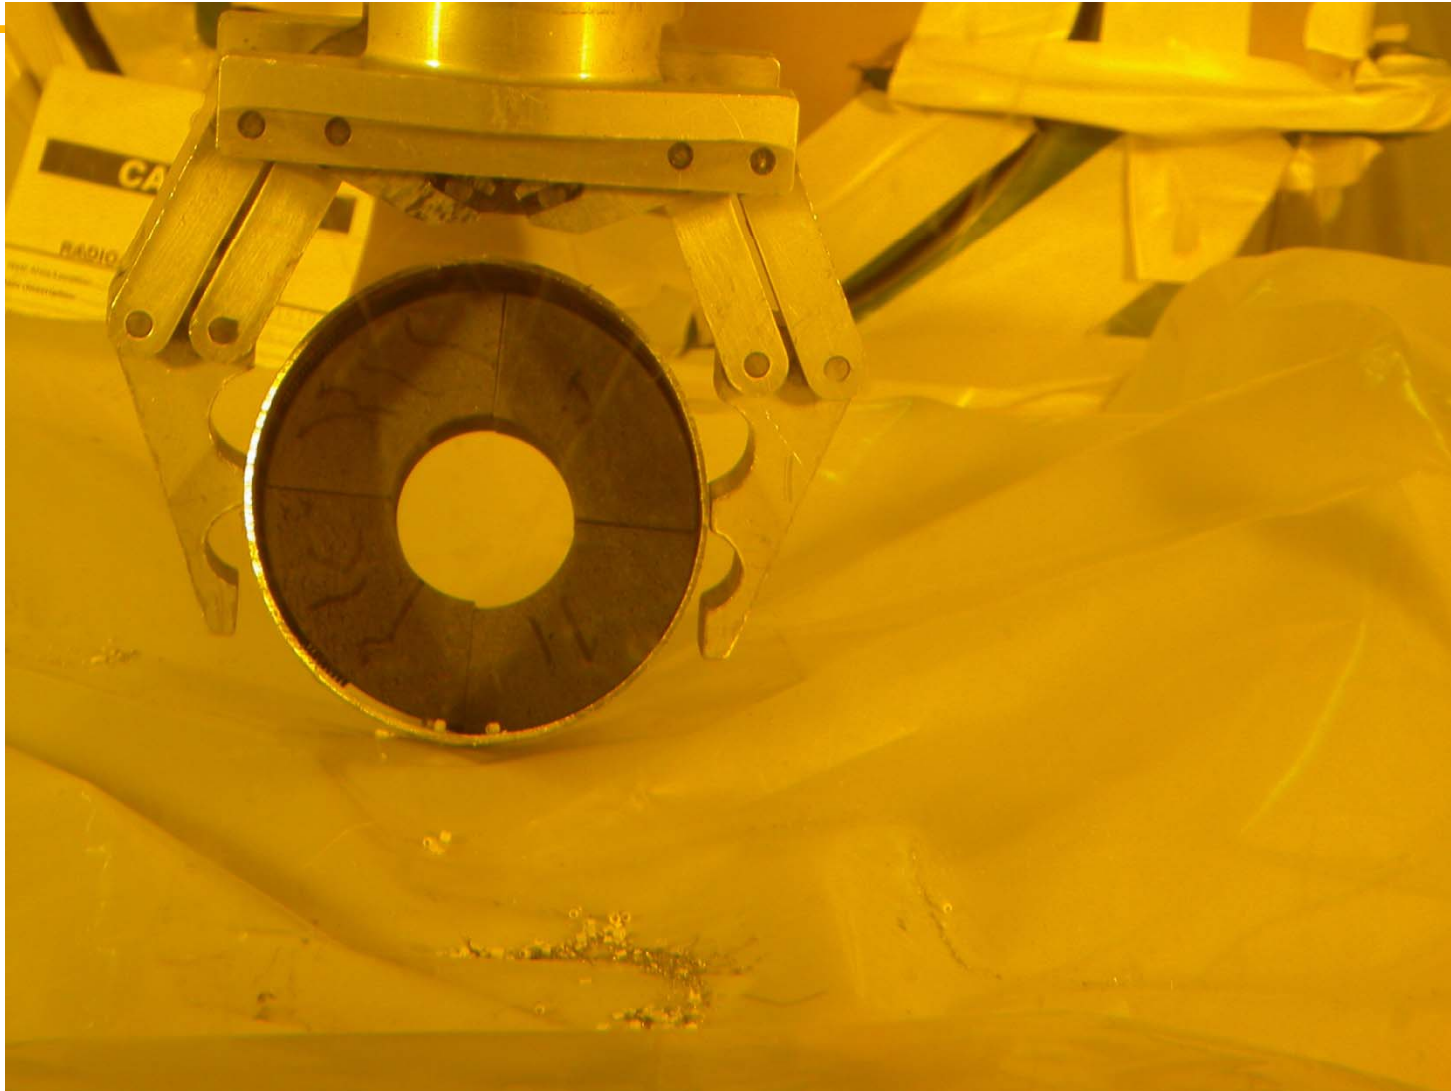
Retaining Springs not Intact

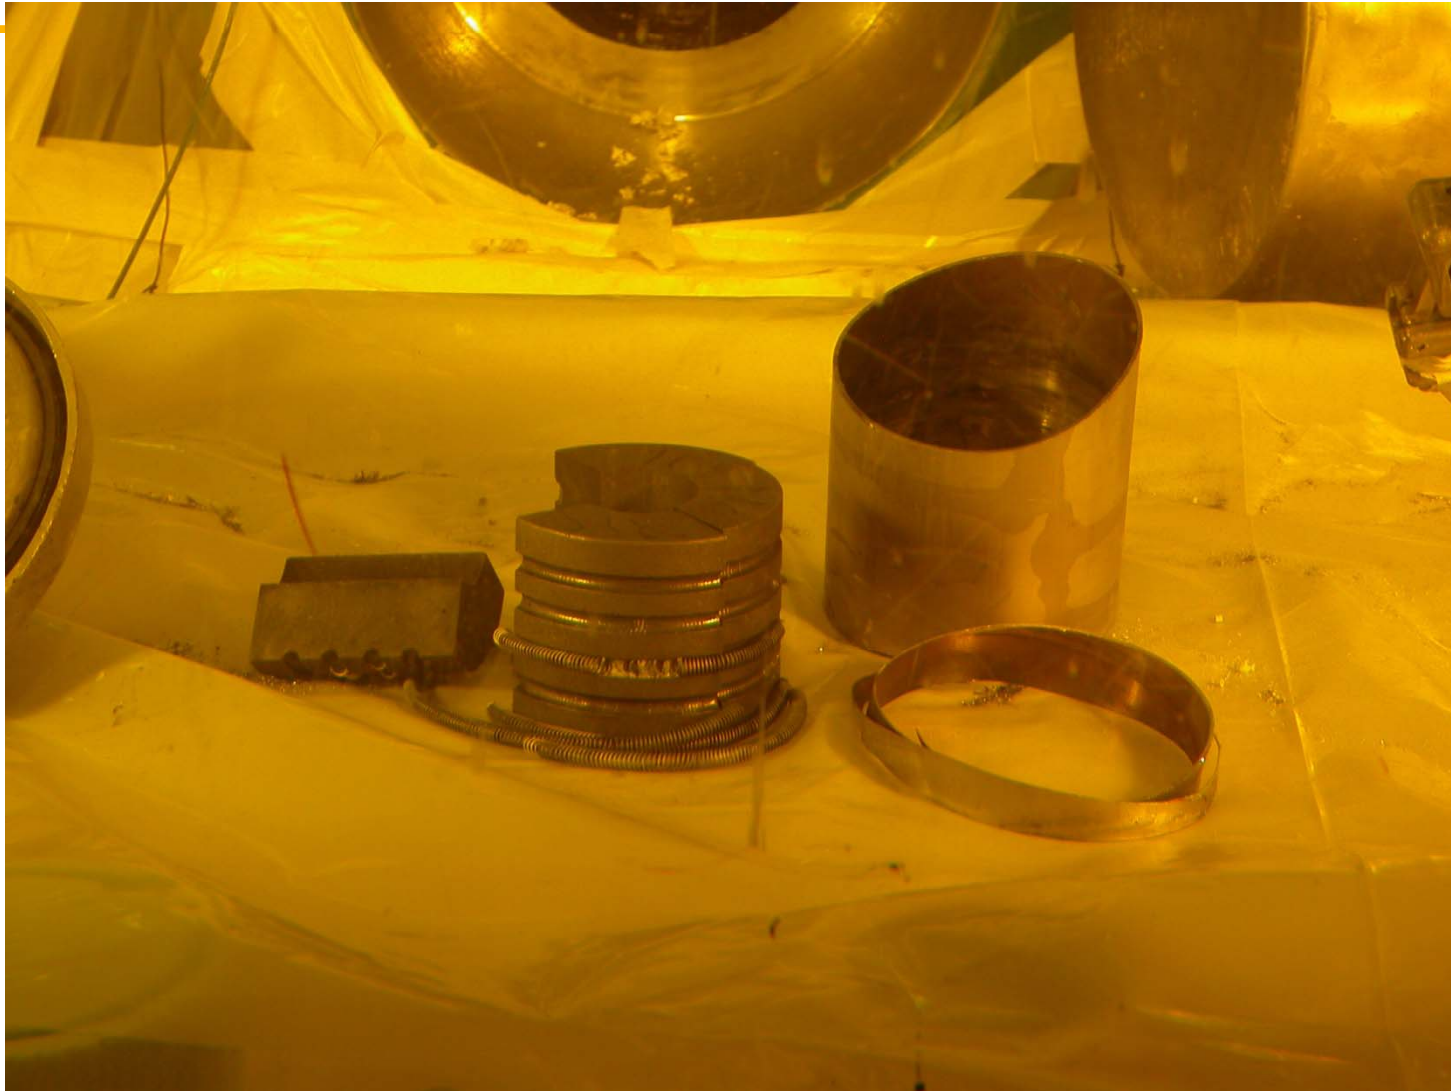
Melted Haynes 25 Spring, 50+R/hr , ~1350C Melt

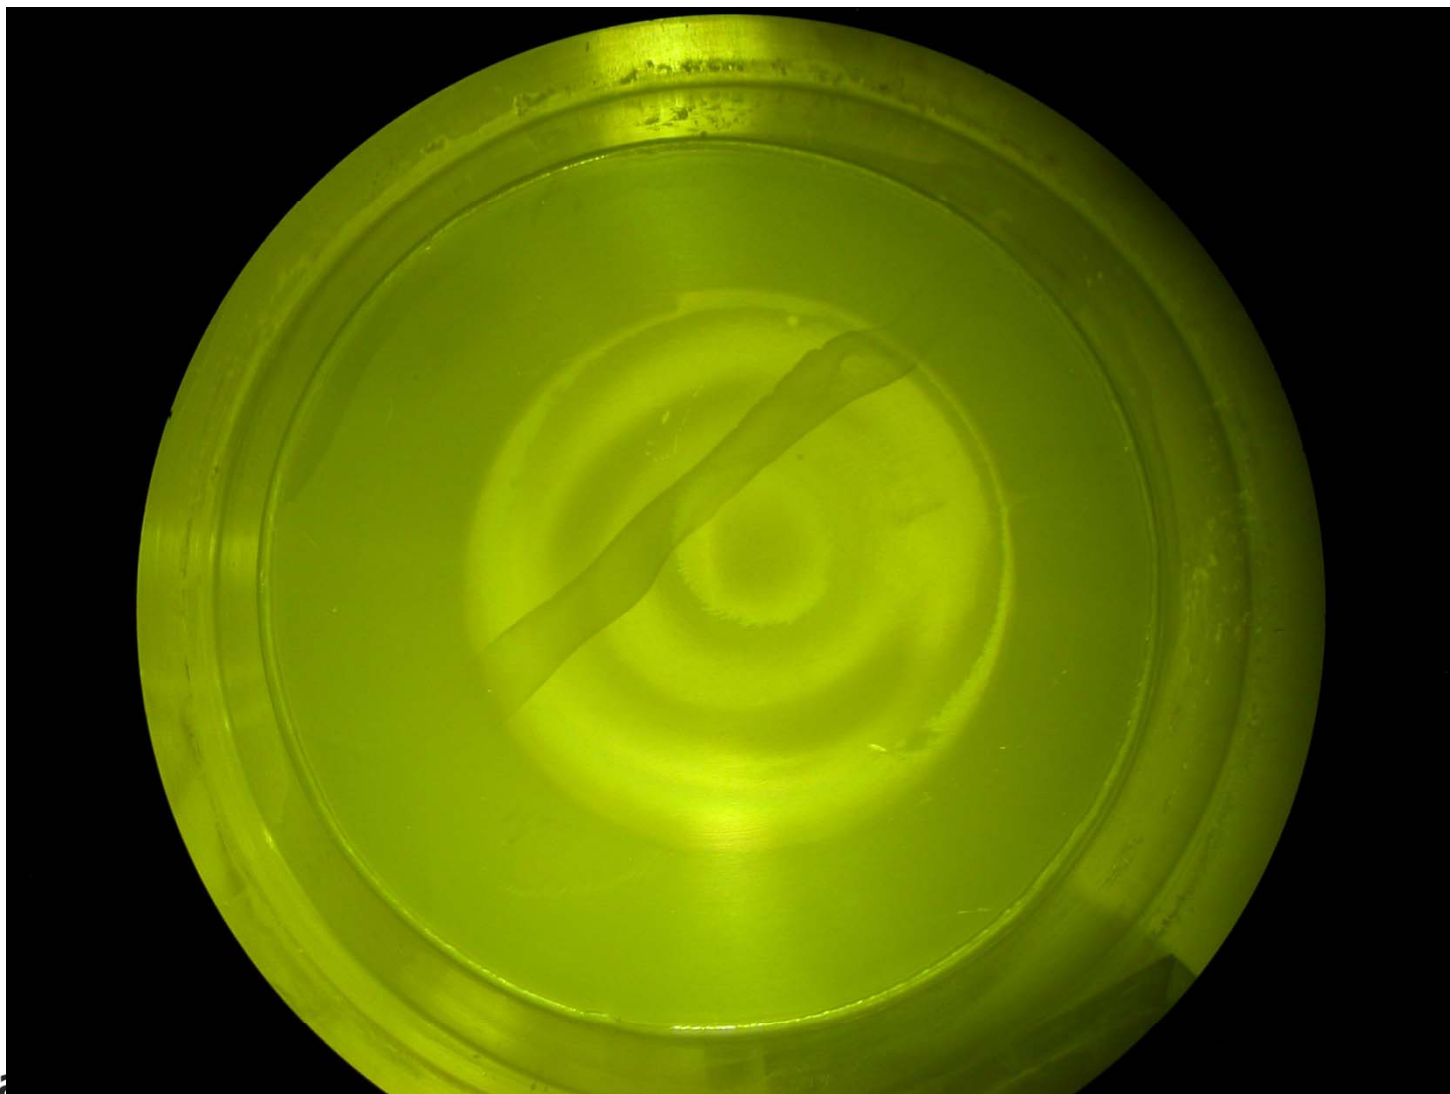
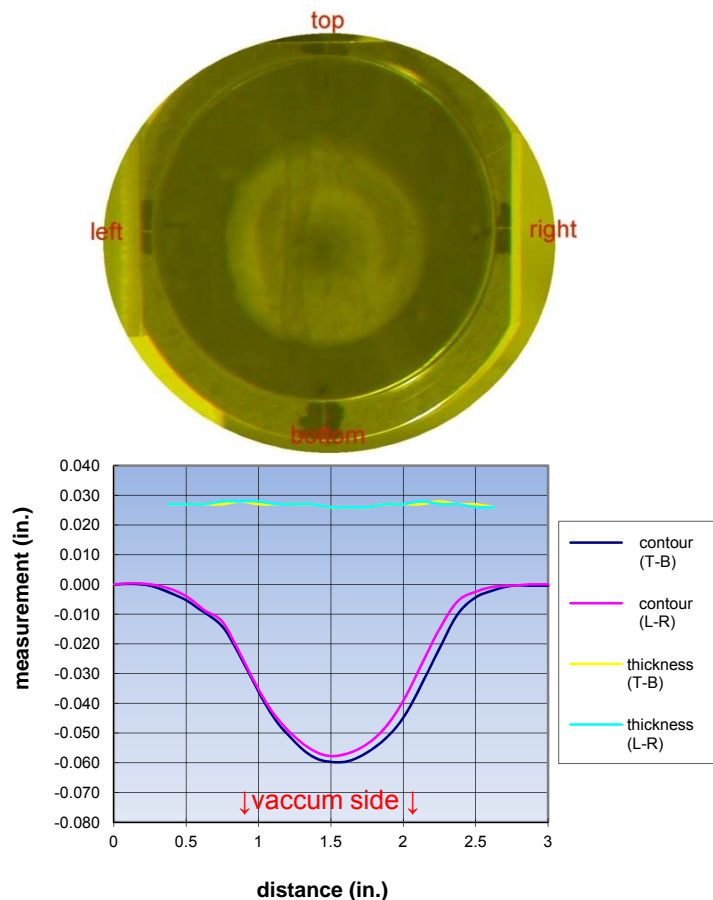
Beam Window Bulging and Beam Profile Measurements

GAFCHROMIC HD-810 dosimetry film was used to measure the absorbed dose of high energy photons from the activated beam window.

Beam window was bulged 1.5mm into the vacuum side.

Rastered beam profile shows a Gaussian distribution and the highest dose region corresponds to the darkest blue region on the Gafchromic film.

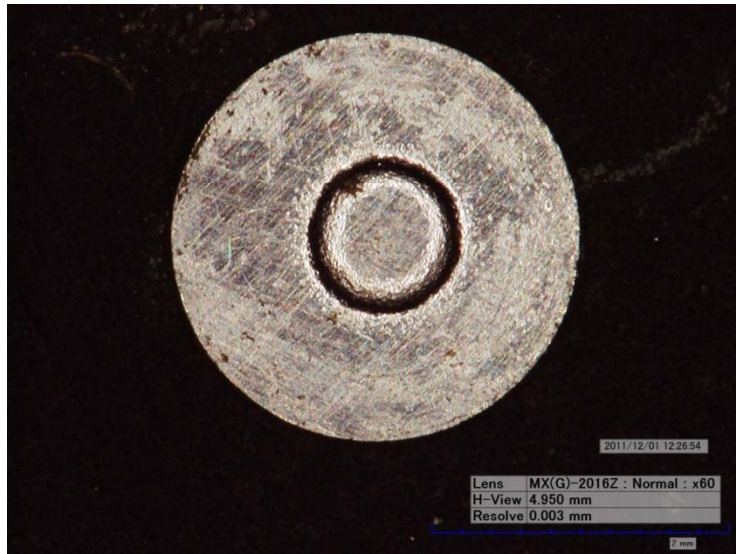
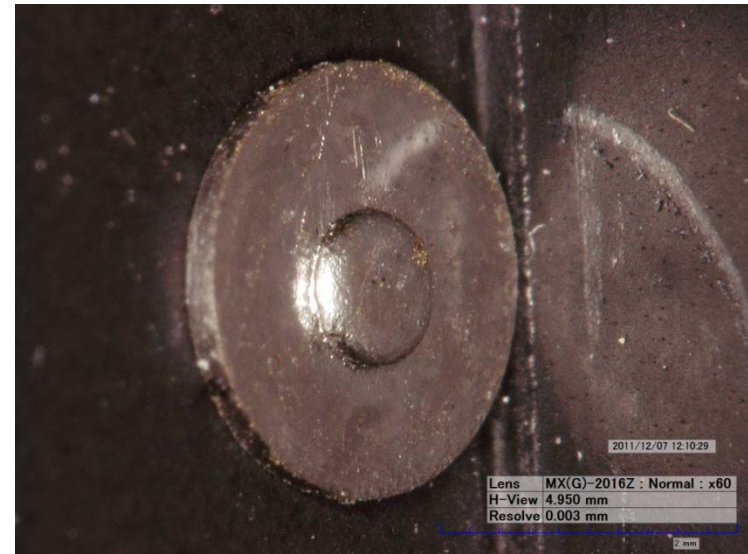
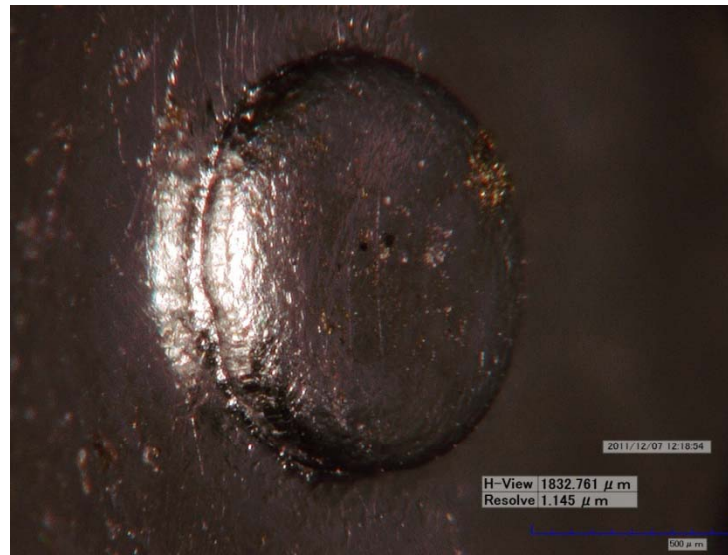
Optical Images of Sample # 3 (High Radiation Ring)

- All samples display ductility in both yield vs UTS and optically.
- Samples taken in outer ring and outside collimator have a higher yield and UTS than control or high radiation dose samples.
 - Expected that they would be similar to the control samples.
- Shear Punch centers are being prepped for FIB and TEM to view radiation damage and initial condition.

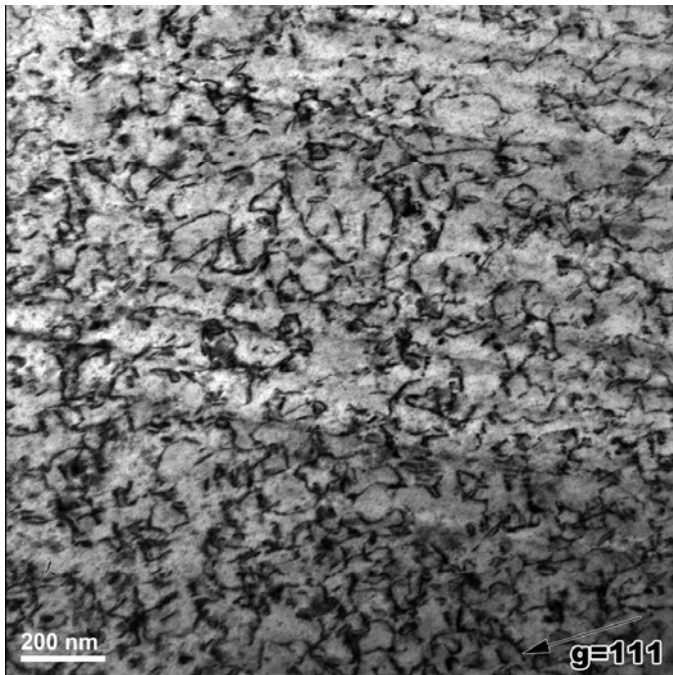
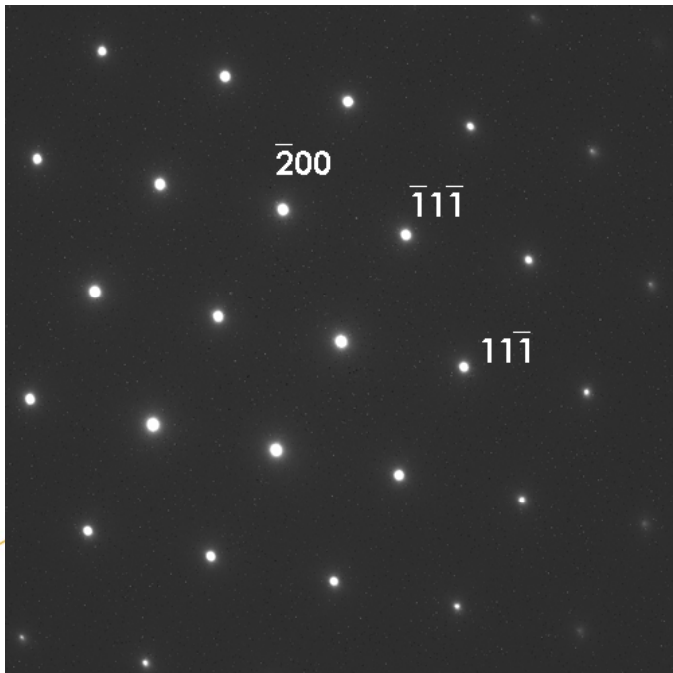
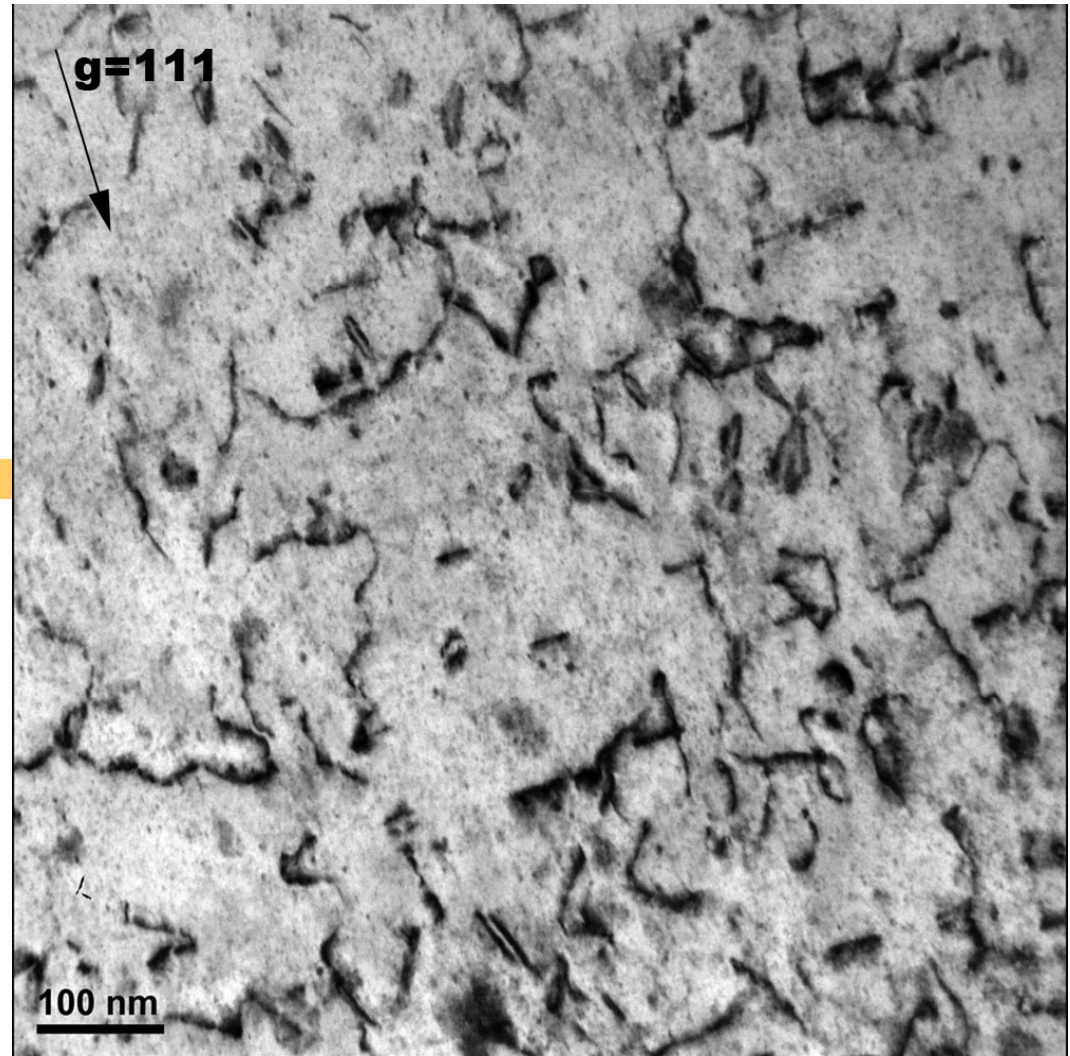
Inconel 718 #5 ~14 dpa @109°C

■ Bright field TEM images showing dislocations, precipitates are not detected?

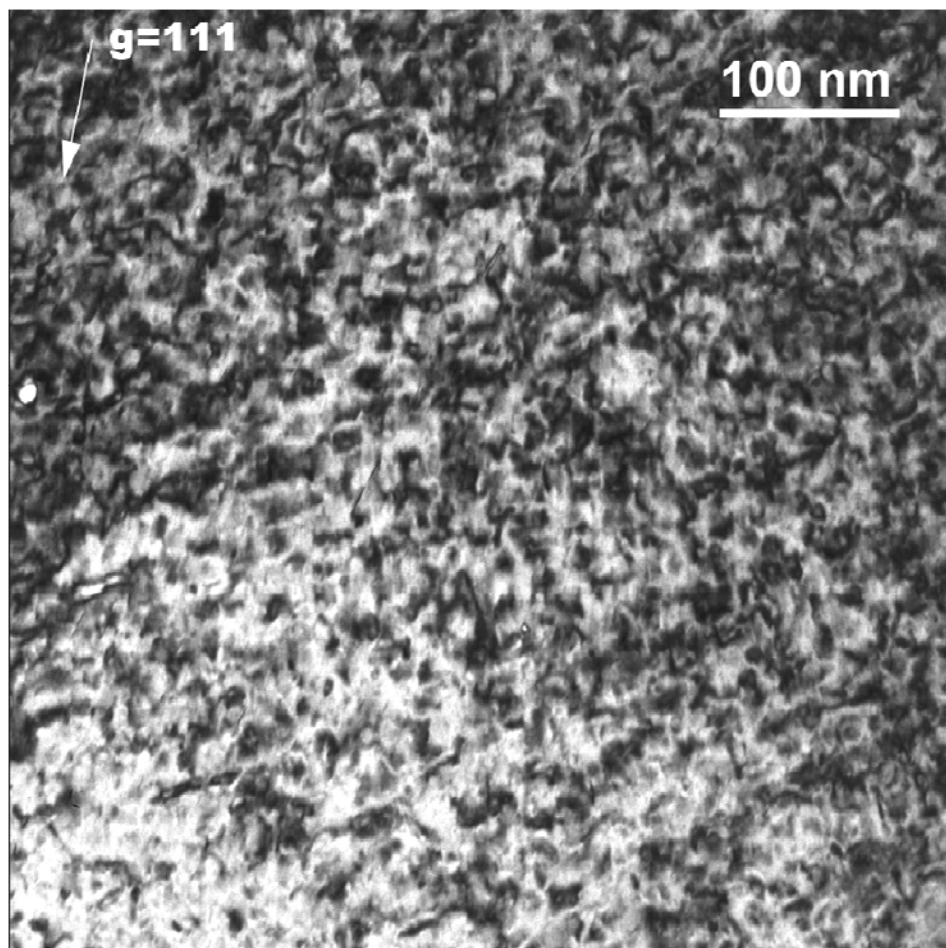
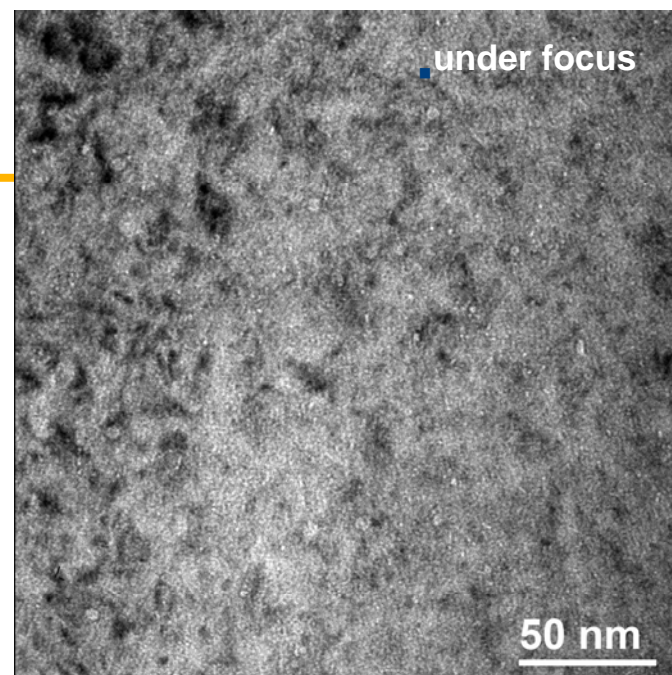
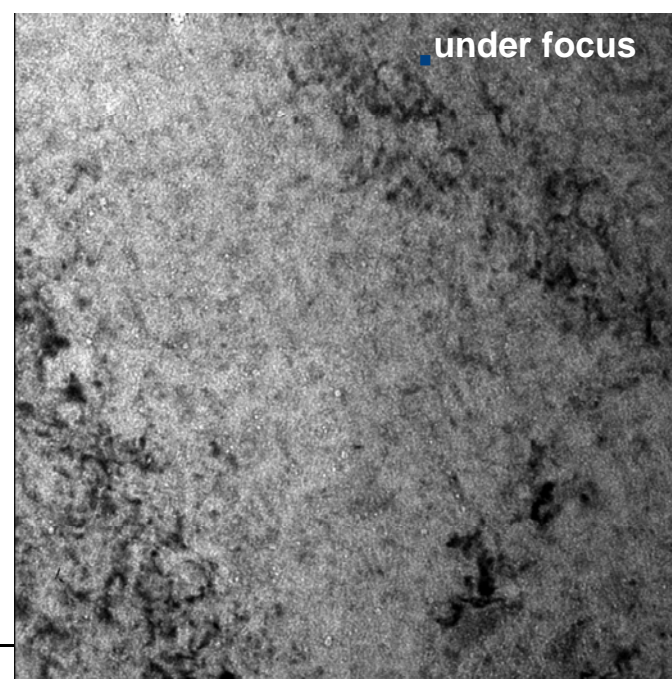
Inconel 718 #19 ~ 0.5 dpa @50°C

■ Bright field TEM images showing dislocation loops.

■ Under focus TEM images on the right are showing a high

density of bubbles/voids that are on the order of 5-10nm.
